Our Reference: S11533-L01

Strata Plan SP 34151

re: FIRE DOOR ASBESTOS SURVEY

The following report provides the results of the investigation into the asbestos status of the fire doors within Pacific Harbour located at 42-44 Victoria Parade, Manly NSW 2095. The fire door survey was undertaken by Andrzej Czwakiel of Hibbs & Associates Pty Ltd (Hibbs) on Monday 14 December 2020.

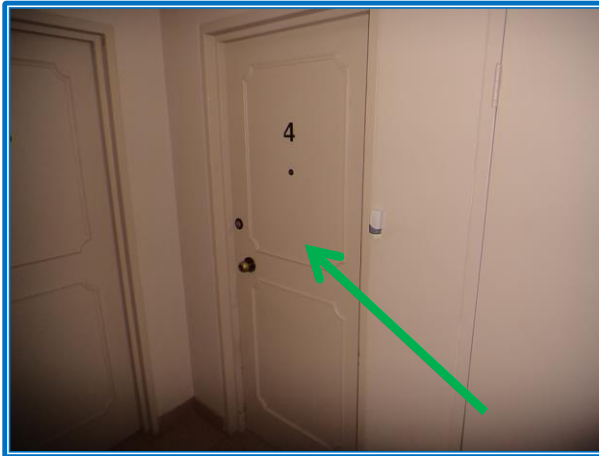
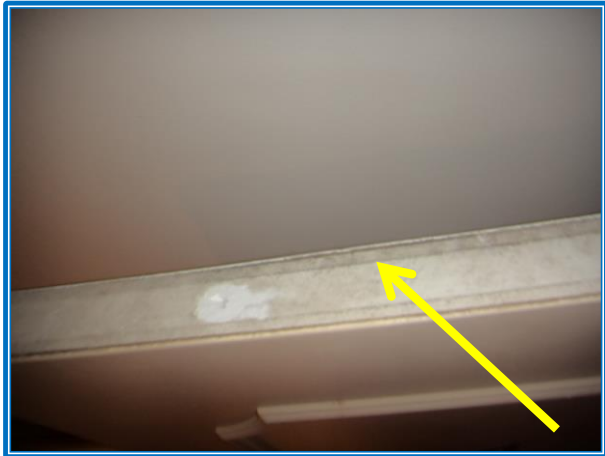
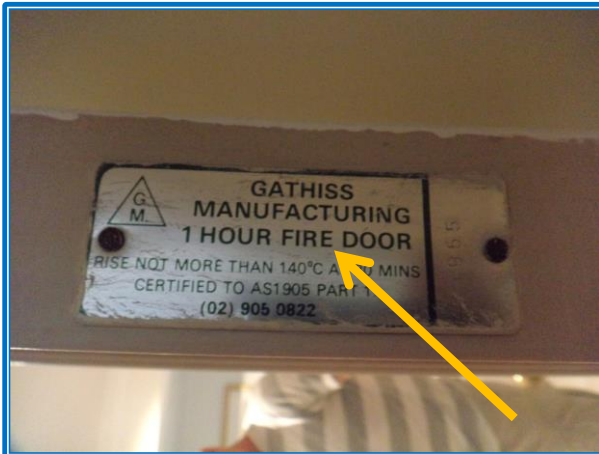
Photographs 01, 02 & 03

The green arrow points to unit 4 front fire door on level 1 (ground floor) that does not contain asbestos. The yellow arrow points to the non-asbestos core visible at the top of the door. The orange arrow points to the compliance plate.

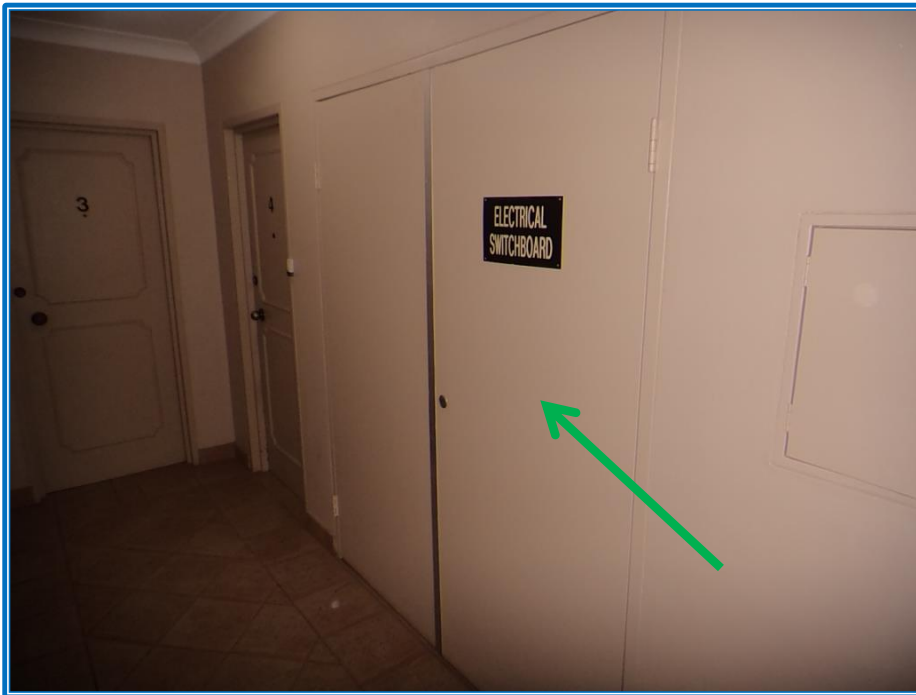
Photograph 04

The green arrow points to the electrical switchboard fire door on level 1 (ground floor) that does not contain asbestos. This door was locked at the time of survey inspection.

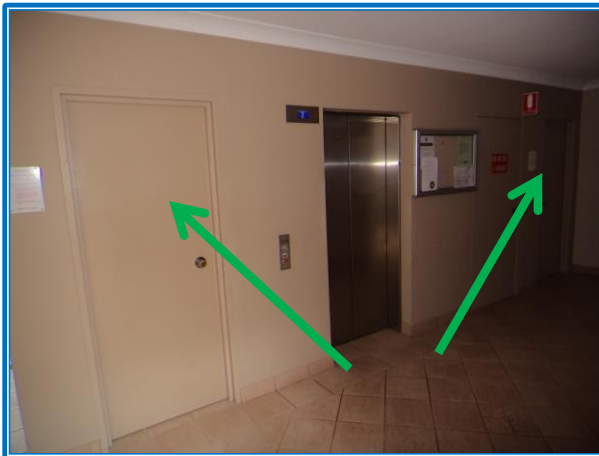
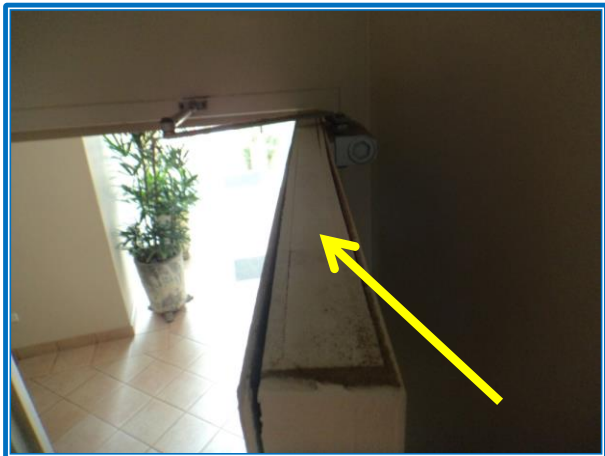
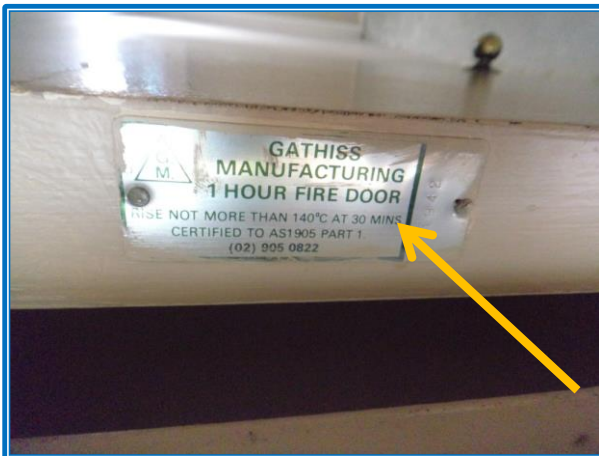
Photographs 05, 06 & 07

The green arrows point to the north and south fire stair doors on level 1 (ground floor) that do not contain asbestos. The yellow arrow points to the non-asbestos core visible at the top of the door. The orange arrow points to the compliance plate.

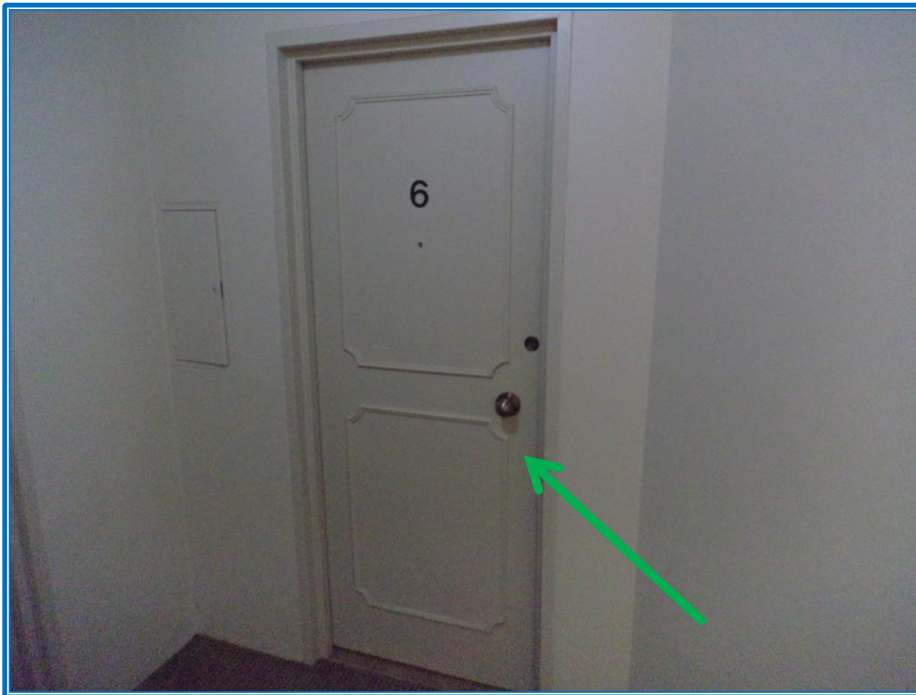
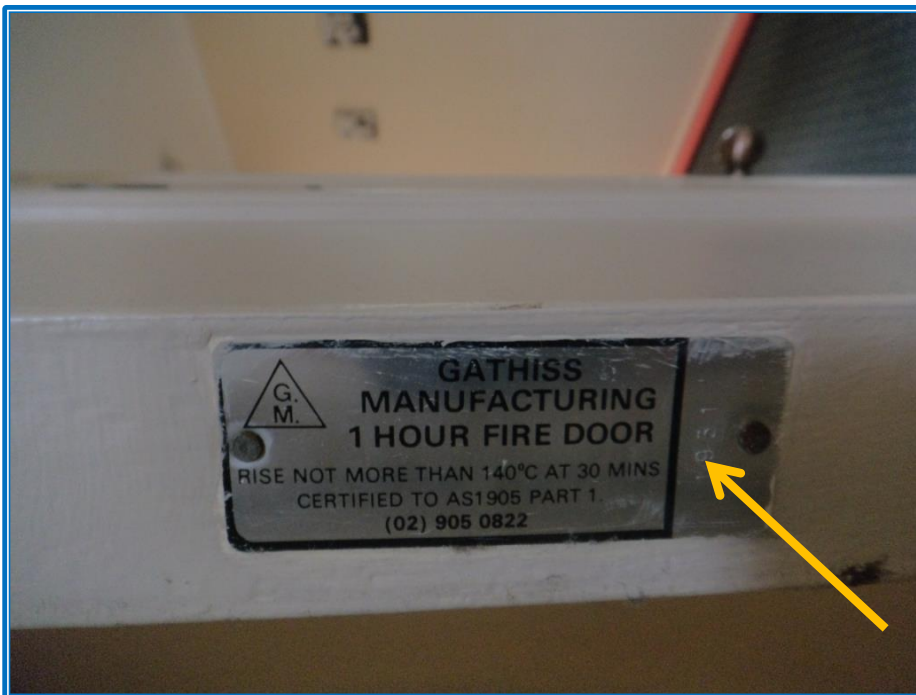
Photographs 08 & 09

The green arrow points to unit 6 front fire door on level 2 (first floor) that does not contain asbestos. The orange arrow points to the compliance plate.

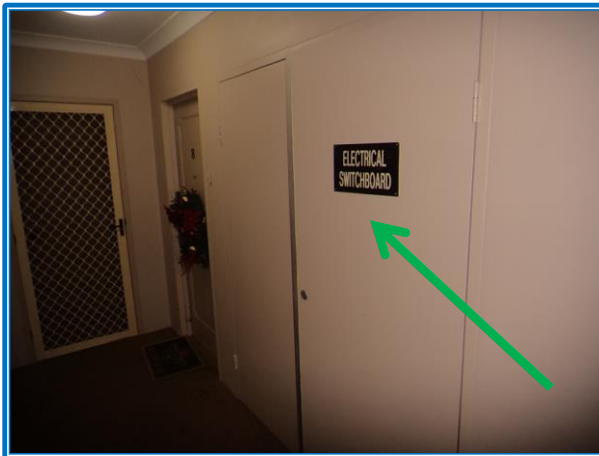
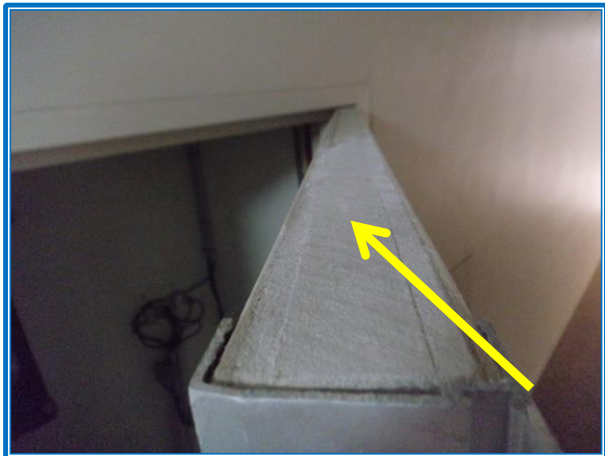
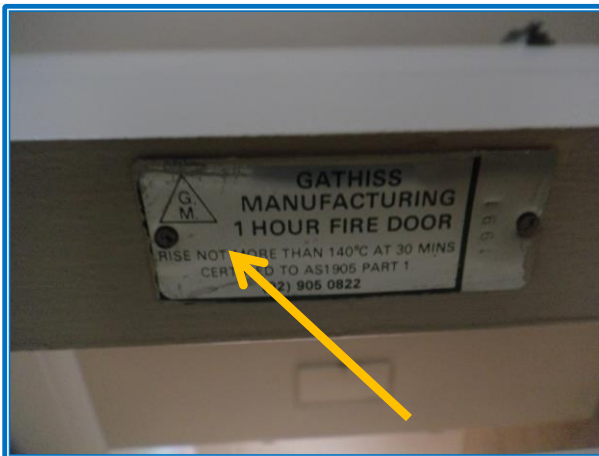
Photographs 10, 11 & 12

The green arrow points to the electrical switchboard fire door on level 2 (first floor) that does not contain asbestos. The yellow arrow points to the non-asbestos core visible at the top of the door. The orange arrow points to the compliance plate.

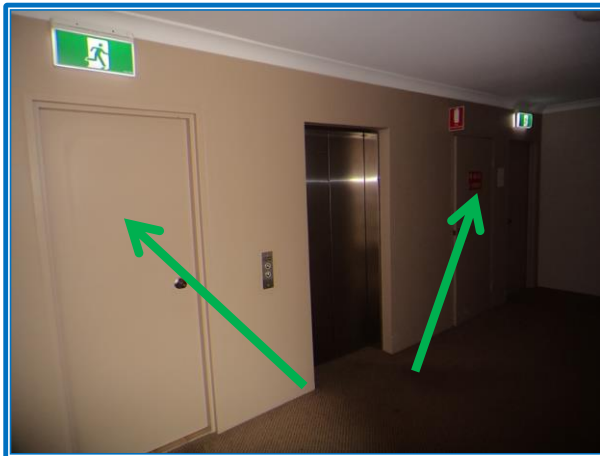
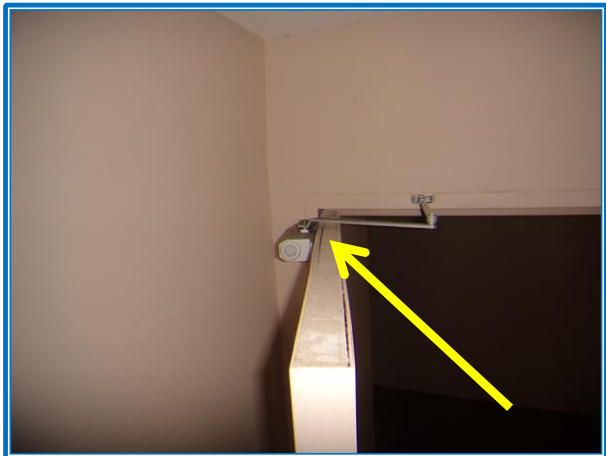
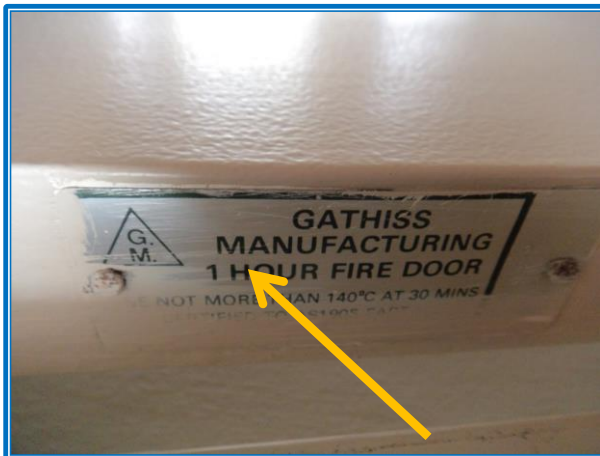
Photographs 13, 14 & 15

The green arrows point to the north and south fire stair doors on level 2 (first floor) that do not contain asbestos. The yellow arrow points to the non-asbestos core visible at the top of the door. The orange arrow points to the compliance plate.

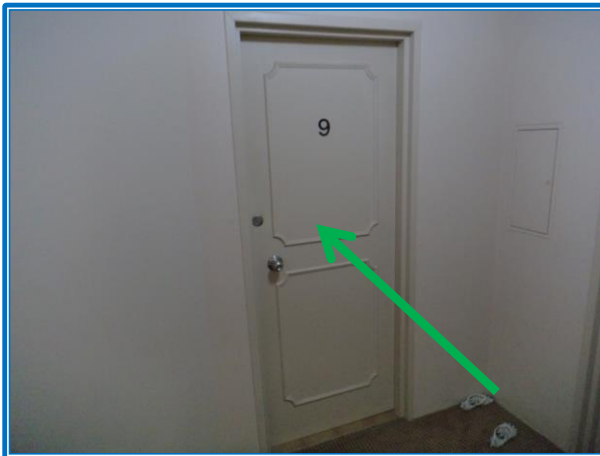
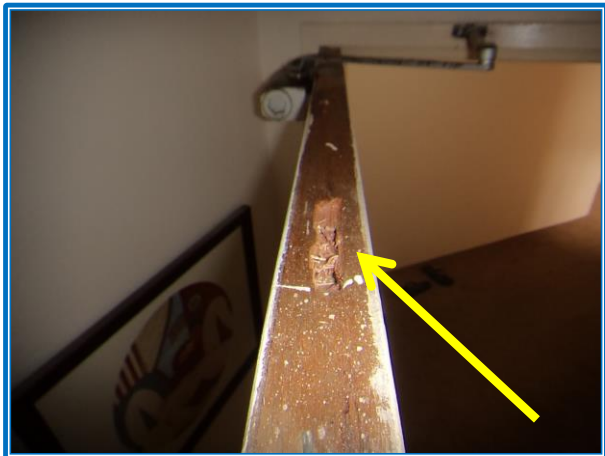
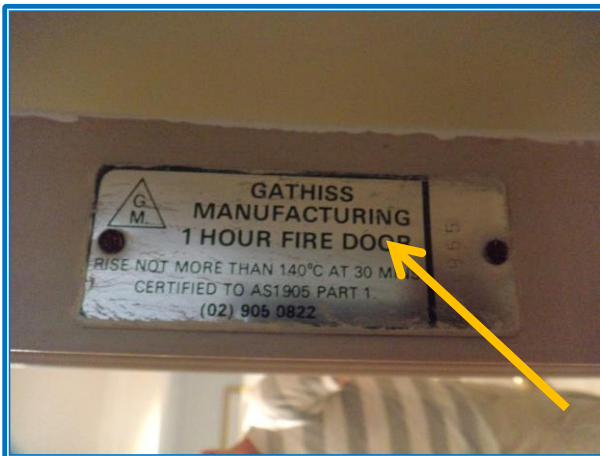
Photographs 16, 17 & 18

The green arrow points to unit 9 front fire door on level 3 (second floor) that does not contain asbestos. The yellow arrow points to the timber core at the top of the door. Minimal damage was done to the timber core to maintain the integrity of the finish. The orange arrow points to the compliance plate.

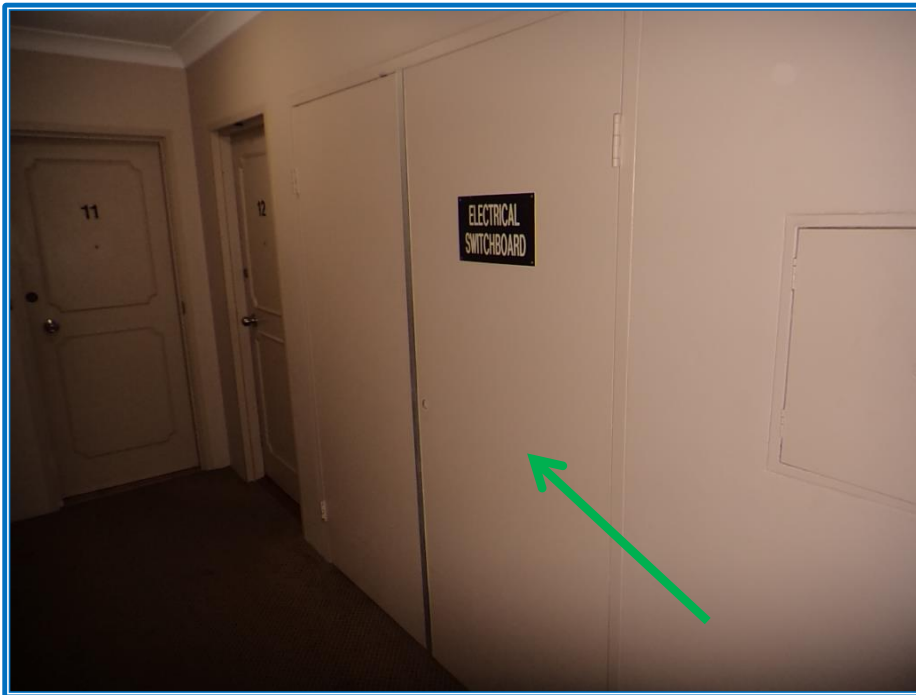
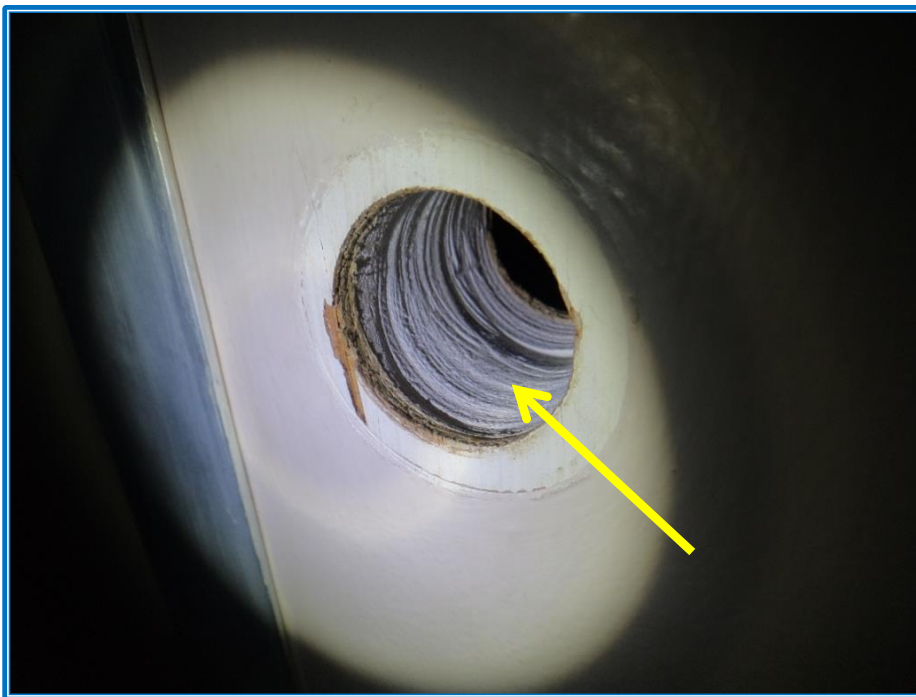
Photographs 19 & 20

The green arrow points to the electrical switchboard fire door on level 3 (second floor) that does not contain asbestos. The yellow arrow points to the non-asbestos core visible through the doorknob's hole. This door was locked at the time of survey inspection.

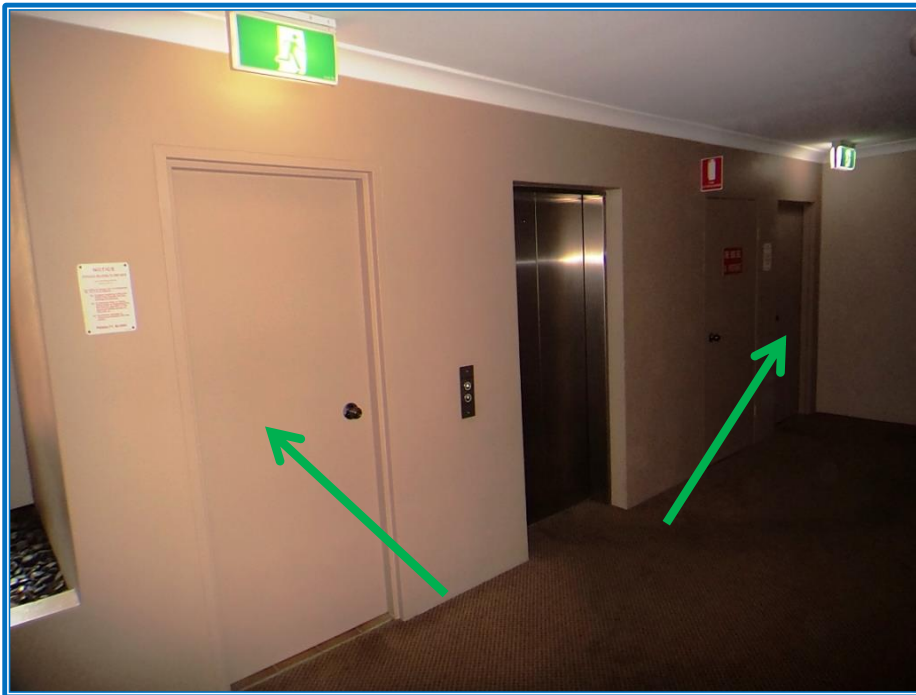
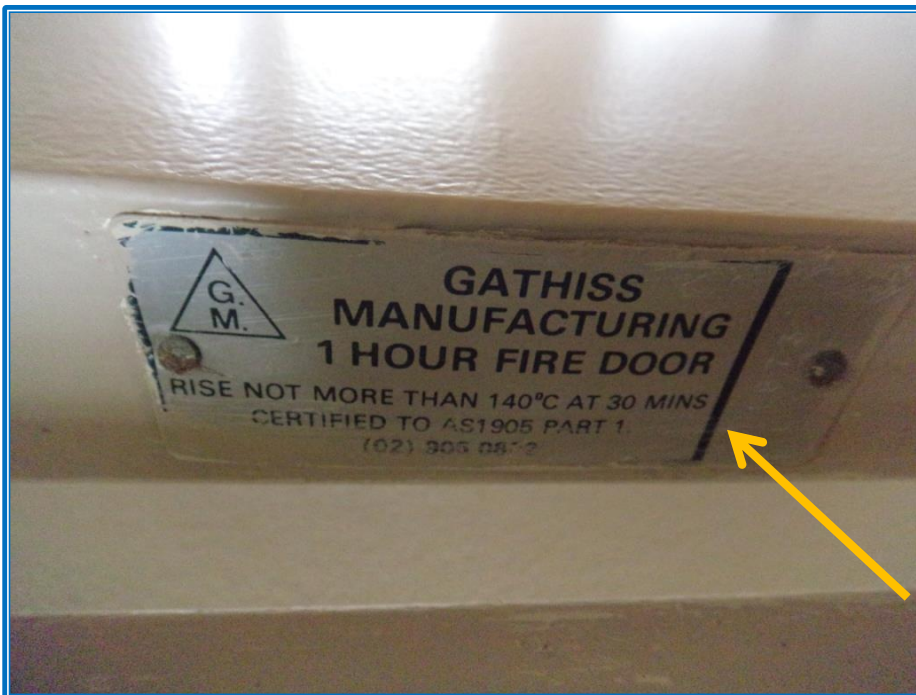
Photographs 21 & 22

The green arrows point to the north and south fire stair doors on level 3 (second floor) that do not contain asbestos. The orange arrow points to the compliance plate.

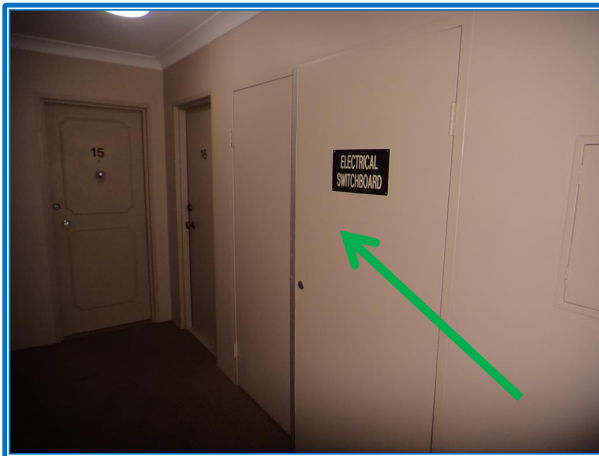
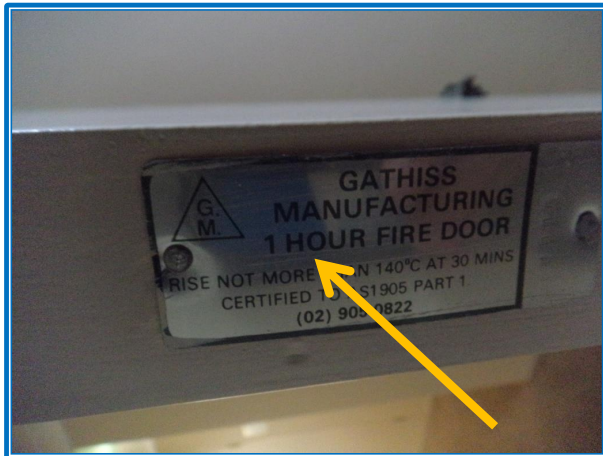
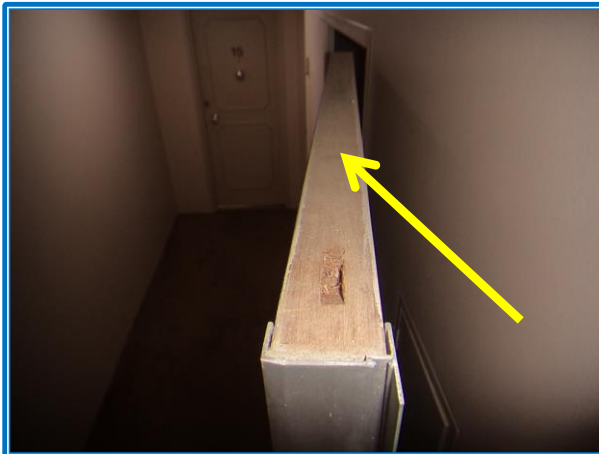
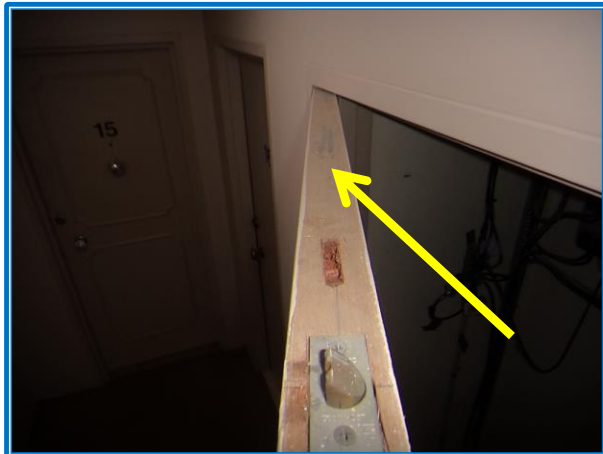
Photographs 23, 24, 25 & 26

The green arrow points to the electrical switchboard fire door on level 4 (third floor) that does not contain asbestos. The yellow arrows point to the timber core at the top of the door. Minimal damage was done to the timber core to maintain the integrity of the finish. The orange arrow points to the compliance plate.

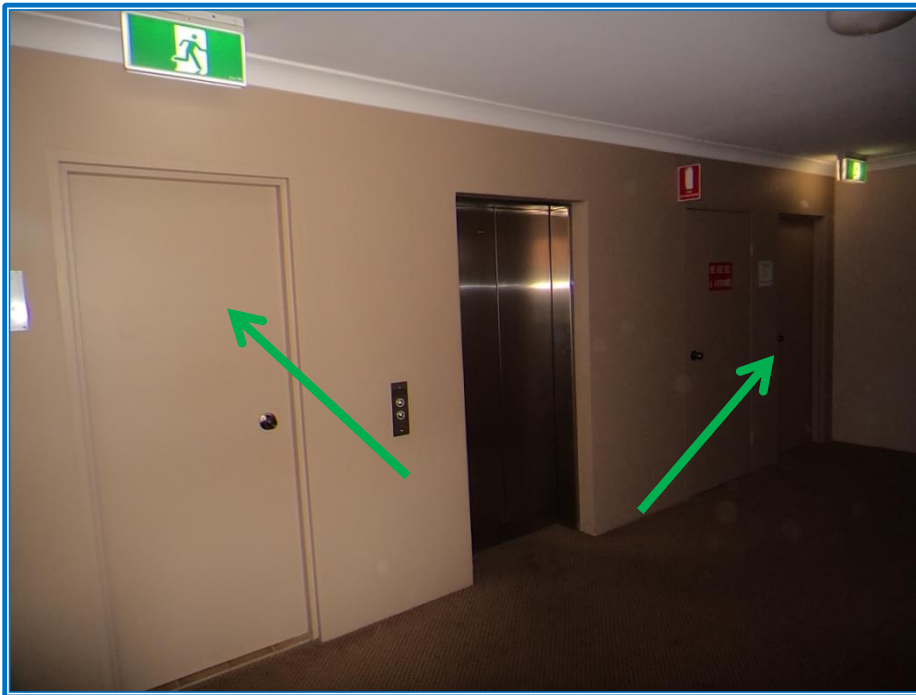
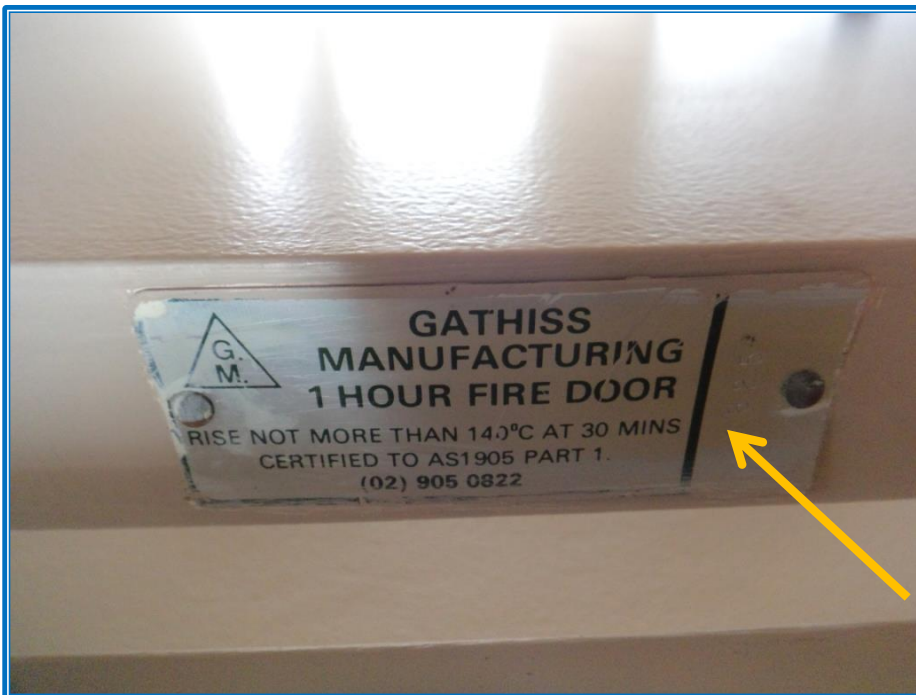
Photographs 27 & 28

The green arrows point to the north and south fire stair doors on level 4 (third floor) that do not contain asbestos. The orange arrow points to the compliance plate.

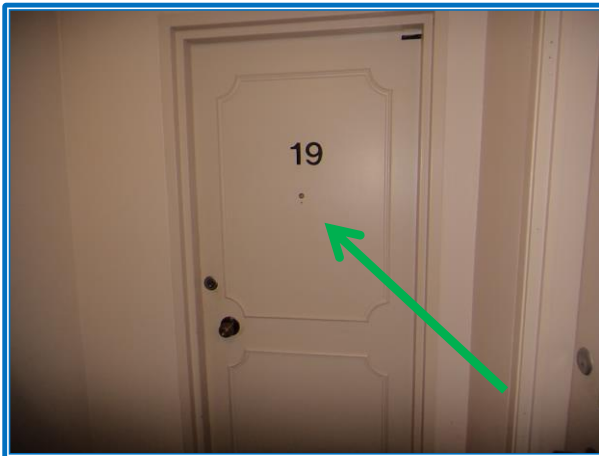
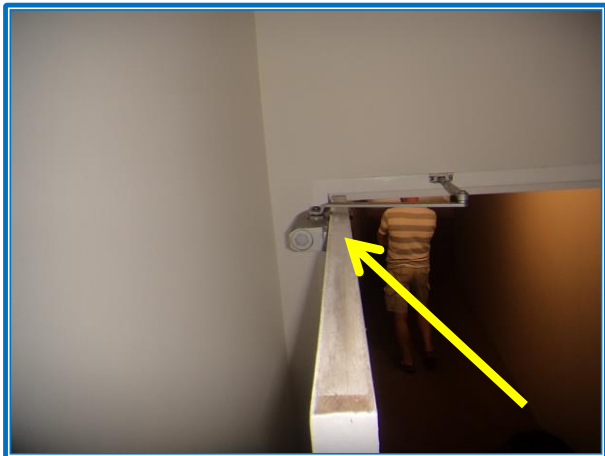
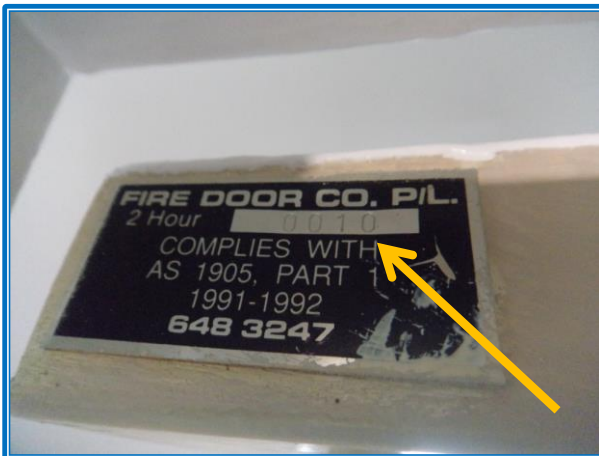
Photographs 29, 30 & 31

The green arrow points to unit 19 front fire door on level 5 (fourth floor) that does not contain asbestos. The yellow arrow points to the non-asbestos core visible at the top of the door. The orange arrow points to the compliance plate.

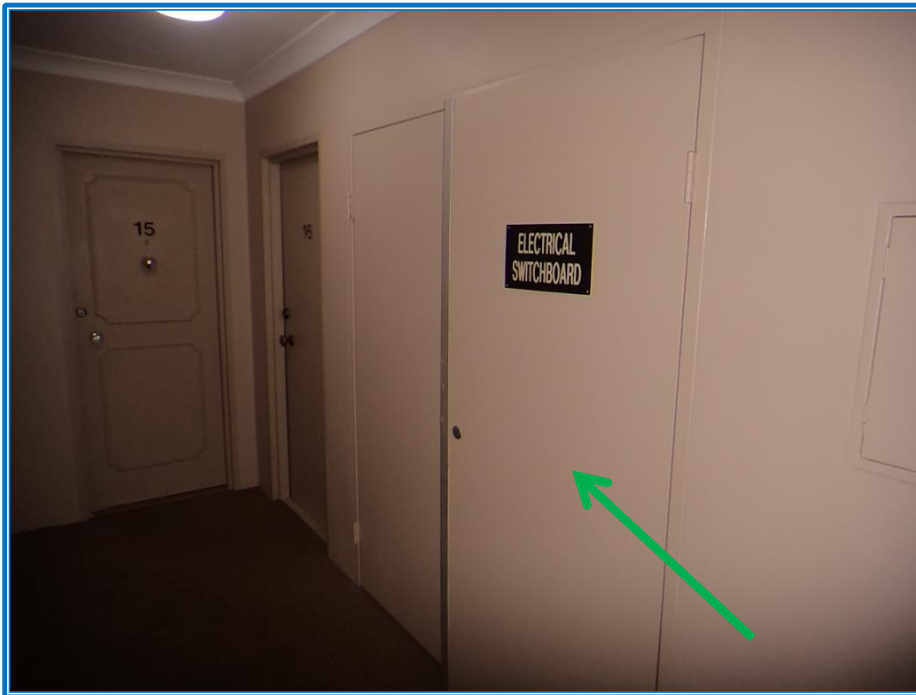
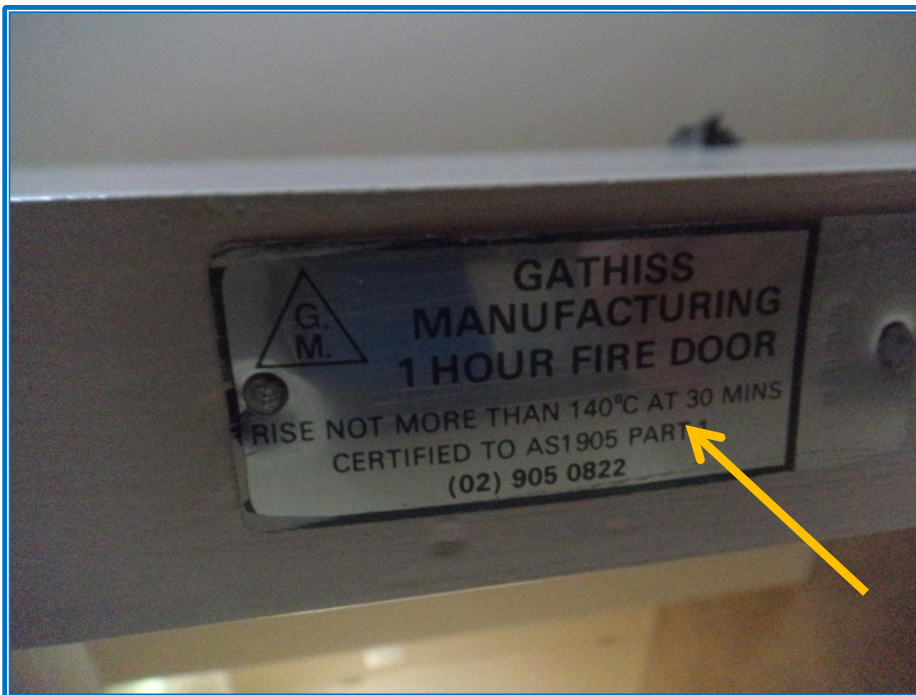
Photographs 32 & 33

The green arrow points to the electrical switchboard fire door on level 5 (fourth floor) that does not contain asbestos. The orange arrow points to the compliance plate.

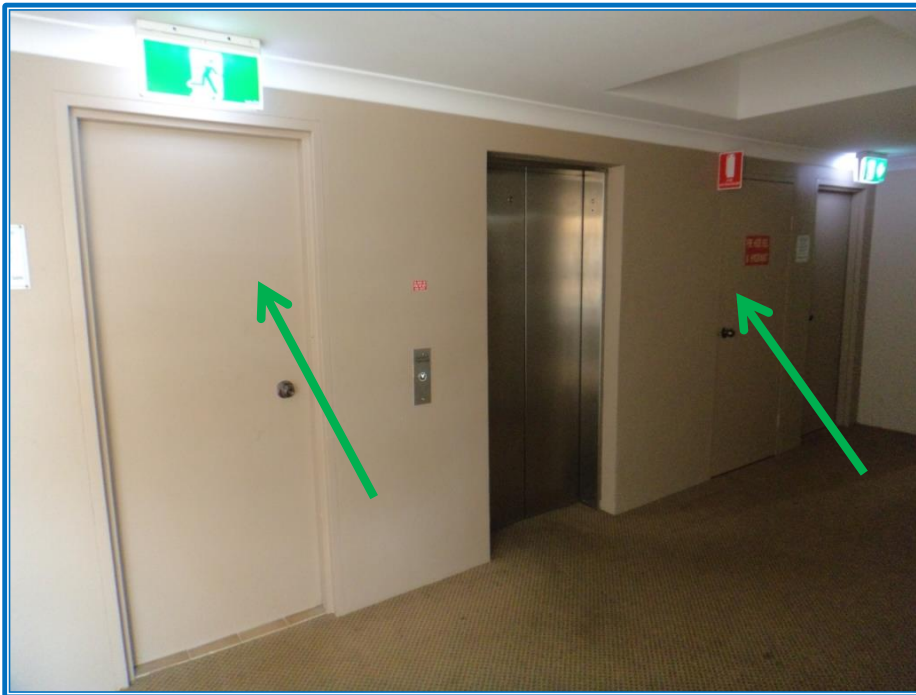
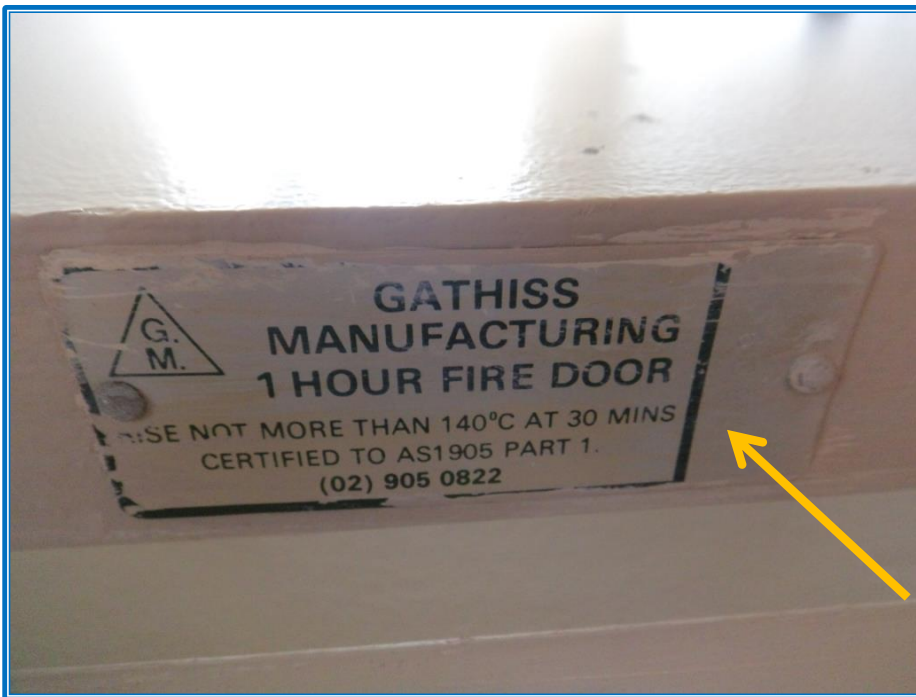
Photographs 34 & 35

The green arrows point to the north and south fire stair doors on level 5 (fourth floor) that do not contain asbestos. The orange arrow points to the compliance plate.
