Capital Works Fund Analysis - March 2021

'PACIFIC HARBOUR'
42-44 Victoria Parade, Manly

The Owners Corporation of Strata Plan 34151

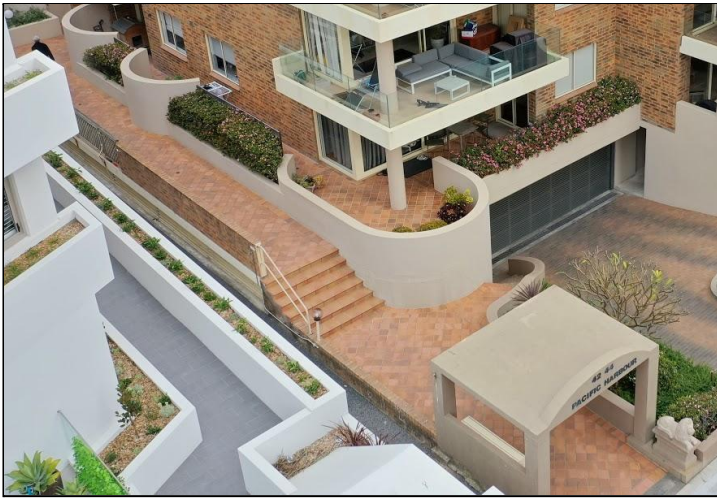
The pedestrian entry from Victoria Parade through the Portico, up the external stairs, along the

elevated walkway to the building's main entrance has degraded since the initial construction in 1988. There have been minor repairs over the years, but dilapidation has accelerated and underlying problems with garden beds have been revealed. The Owners Corporation was generally patient with addressing improvements until the construction of the neighboring building was complete.

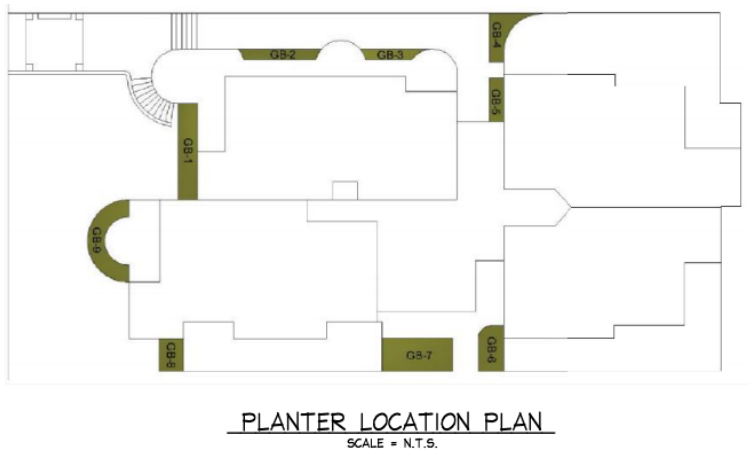
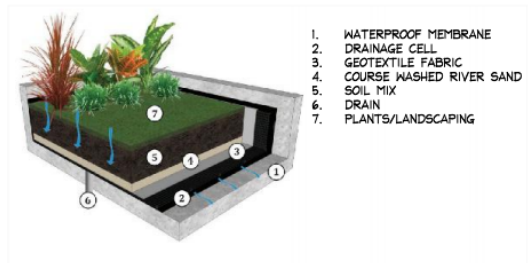
2.1.1. Garden Beds 1-5

Identification of Garden Beds

1. Remove and dispose of all garden bed contents.
2. Removal of internal wall of garden bed.
3. Strip out of garden bed drain and dressing of the affected area.
4. Install glass balustrade to top of ext. balustrade upstand (to match other units).
5. Remove all balcony tiles on unit 4 balcony.
6. Replace drains with strip drains and connect to site stormwater.
7. Waterproof unit 4 terrace and tile.

- Remove and dispose of all garden bed contents (except GB2).
- Replace irrigation pipe (raise above garden bed height and cap) and repair the penetration seal (GB2 only).
- Seal electrical cable penetration (GB2-GB4).
- Timber lattice to be stripped back and prepared for painting (GB2-GB3). Colour Eva-Last Spanish Saffron.
- Ensure drain and drain seal are adequate, and repair as necessary (GB4-GB5).
- Repair and resurface the external edge along the property boundary (GB4).

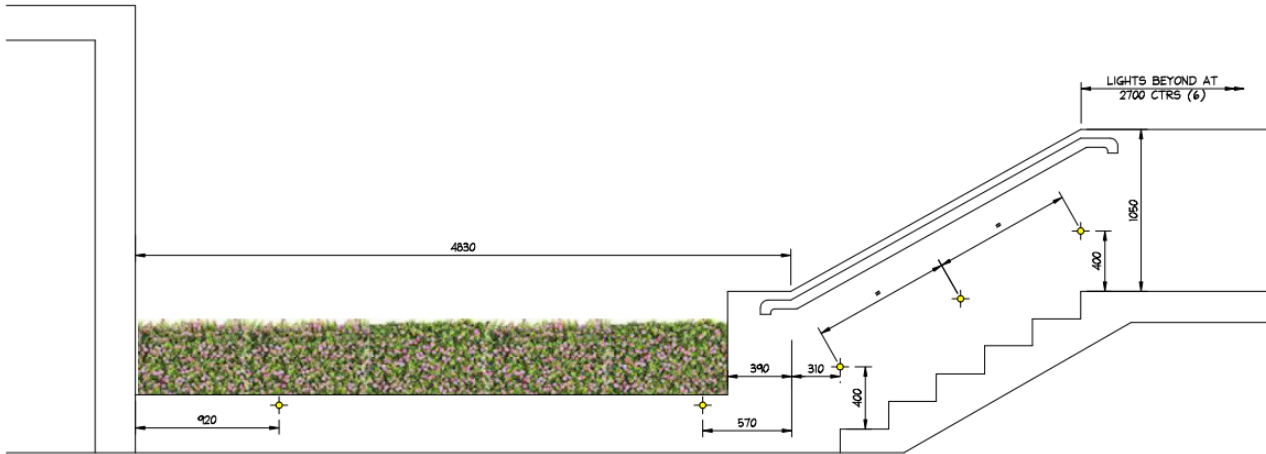
STAIR ELEVATION
SCALE = 1:20

The boundary wall at the entry walkway has a failing handrail at the stairs and a dilapidated wooden fence balustrade. The following is the procedure for the boundary wall:

1. The timber panels and handrail shall be removed and disposed of
2. A brick wall shall be constructed to replace the wooden fence to 1m in height. The wall shall be a 230mm brickwork wall laid on the concrete slab.
3. The existing wall shall be extended in height to match for the walkway length and on the rake to the bottom of the stairs. Common bricks may be used.
4. The entire wall shall be rendered (all exposed surfaces).
5. A new brass handrail shall be installed and fitted to the rendered raked brickwork wall at the stairs.
6. Coring of the wall and walkway lights shall be installed. The lights shall be installed in PVC sleeves. In total it shall be 11 cores and lights.

1. All existing tiles are to be removed and disposed of.
2. Once the slab is exposed, the slab shall be tap tested and any drummy area, exposed reinforcement or the like treated with the procedure in item E6.
3. Waterproofing shall be installed to manufacturer's specification and turned down into the drainage to prevent moisture transmission around the penetrations.
4. Sand screed required to achieve falls shall either have a lime binding additive or a top membrane to prevent lime leaching.
5. The selected tile is a 600x600x10 Ella Stone (19-1004) with P5 slip rating. Stair nosings are to be non-skid in accordance with clause D2.13 and clause D2.14 of the current BCA and the nosings are to have a minimum 30% luminance contrast to the background.
