Capital Works Fund Analysis - March 2021

'PACIFIC HARBOUR'
42-44 Victoria Parade, Manly

The Owners Corporation of Strata Plan 34151

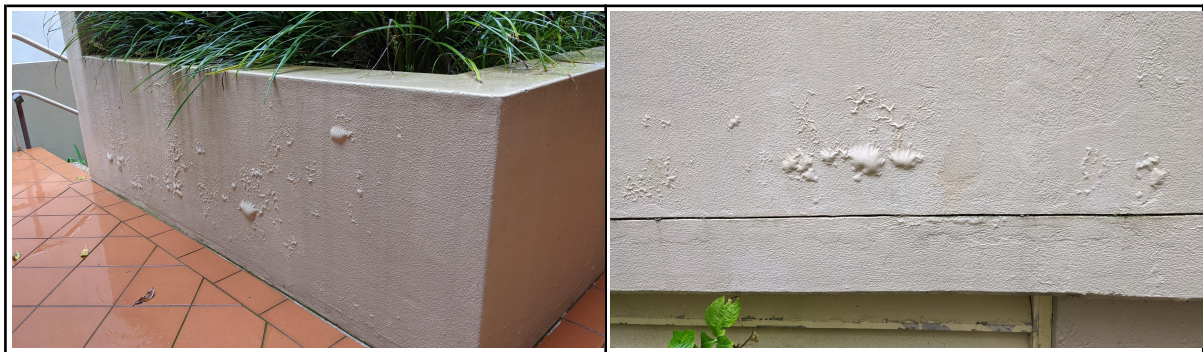
2.2.4. Garden Beds 6-9

The failing condition of garden beds 1-5 clearly requires immediate remedial work. The original bitumen water seals are leaking and the surrounding structures are deteriorating. There is progressive evidence of water seal deterioration for garden beds 6-9 although. Garden bed 7 (large one near the rear entrance) has developed very large water blisters during the recent heavy rains; and this garden bed has a very large tree which would likely have roots that could cause structural problems. There appears to be evidence that garden bed 9 (Unit 3 curved wall) has water seal bitumen seeping through the external render. Unfortunately, progressive evidence of failing conditions is not sufficiently noticeable until surrounding structures begin to fail. Based on the evidence in garden beds 1-5, it would be prudent to pre-emptively refurbish garden beds 6-9. The refurbishment estimate is lower than the other garden beds because there is one less plus there is no current evidence of structure remediation.
